22 October 2012

Reference: Stackpole Creek Bridge, Saco

The following is a summary of our thoughts and opinions regarding the conditions reports and associated recommendations, conditions we have noted in the field, and our own recommendations for repair.

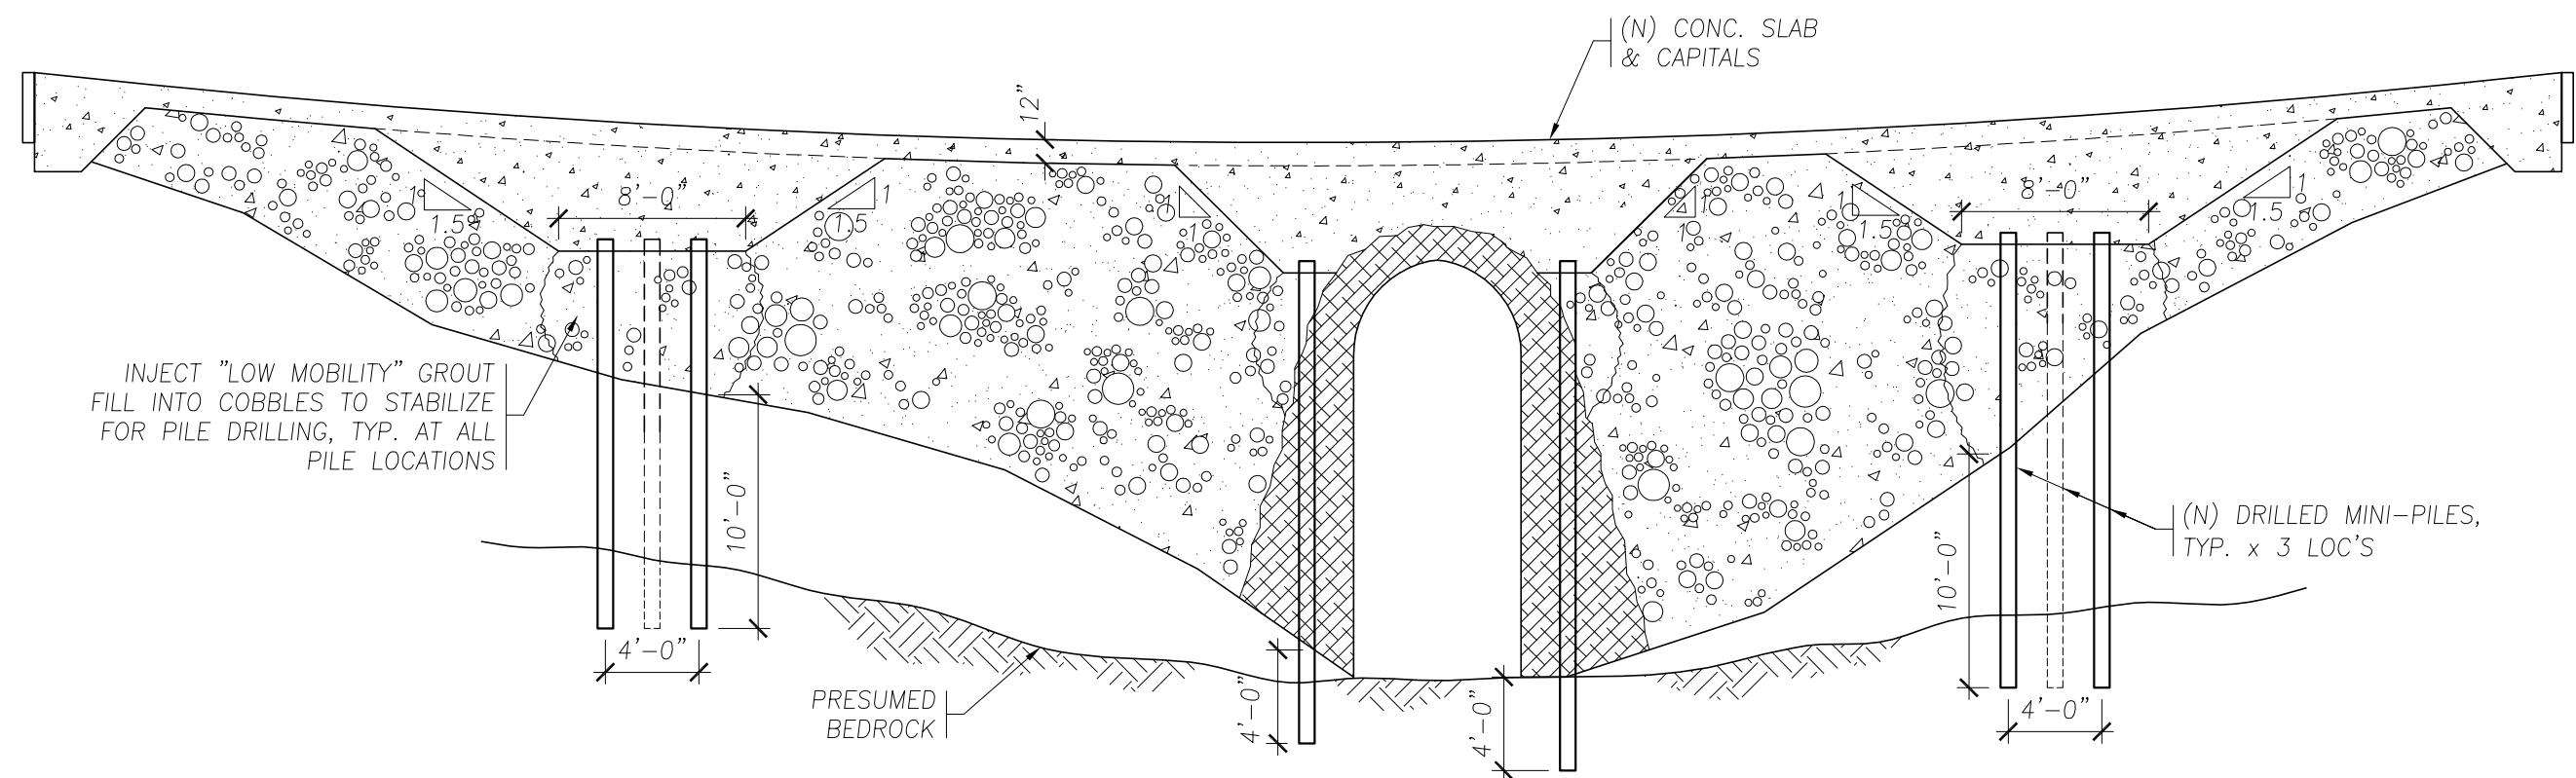
FIG. A: HYBRID SCHEME LONGITUDINAL SECTION
 $\frac{1}{8}'' = 1'-0''$

Under this plan, the lower masonry would be stabilized and restored, with the south side of the structure left unpointed to drain, most of the cobble fill maintained in its free-flowing porous state, and the upper portions of fill and top stone course removed and replaced with a pile assisted concrete roadway, essentially creating a bridge within a bridge.

This would be constructed as follows (please refer to Fig. A and B which graphically represent this scheme):

1. The present asphalt road surface would be removed along with the side rails and top course of stones from the side walls, which would be tagged, numbered, and stored. This lowering creates a plane to receive the concrete slab.

2. The top surface would be excavated an additional 2- to 3-feet down to the top of the cobble fill along the upstream side of the bridge, exposing the back surfaces of the sidewalls, which would be chinked and pointed. Stainless steel pins would be set into the backs of some of the stones. This depression becomes a lowered concrete haunch to help buttress the top of the upstream wall.

3. The bulged sections of the north face would be stabilized by localized injection grouting and pinning, chinking, and removal and re-setting, depending upon the severity and location of the condition. The inter-stone joints on the entire upstream wall surface would then be cut, re-chinked, and pointed.

4. The foundations of the abutment walls would be investigated and stabilized.
5. The tops of the walls would be evened off and re-set to create a uniform top edge that is approximately 10" to 12" below its present height.

6. The cobble fill would be excavated down to expose the top of the arch span and the fill on each side would be solidified with a low motility grout in order to stabilize it for drilling. A series of 2" to 3" diameter holes would be drilled through the grouted fill and into the stone headwalls, into which would be installed Cintec sock anchors that would extend from the sidewalls in a fan like pattern, up into the excavation.

7. Cone shaped depressions would be made in the cobble fill at about mid-distance on the embankment structures to each side of the arch span. These would later be filled with concrete to act as flared capitals or pile caps to support the roadway slab.

8. The inverts of the depressions would be gravity fed with a low-motility grout. This would help solidify the cobble fill to make it easier to drill mini piles.

9. Similar depressions would be created at the end of the span, but to a lower depth.
10. A total of 20 drilled mini piles would be placed within the excavated roadway. These would be of approximately 8" diameter and would pass through the stabilized cobbles and any underlying soil and down to bedrock. Two piles would support each of the abutments, five piles would support each of the intermediate capitals (four vertical, one battered), and three would pass through each of the headwalls below the arch.

11. All of the excavated depressions, along with the buttress at the back of the north wall, would receive reinforcing "cages" and concrete to create effective pile caps on which the concrete road span could be placed. The depression over the arch span would be additionally reinforced to stop its transverse spreading.

12. A 10" to 12" structural reinforced concrete slab and wearing surface would then be placed over the capitals, north side buttress, and the tops of the stone sidewalls and extended out by 4" to 6" to create a proper "drip". Expansion joints would be incorporated over the intermediate capitals, and drained from below, and the slab surface would be given a gentle crown, for drainage off to the sides.

13. New Maine DOT approved wooden guardrails would be installed at each side.
14. Stone rip-rap would be laid at the base of the downstream wall and training walls, would be added at the front of the arch span.

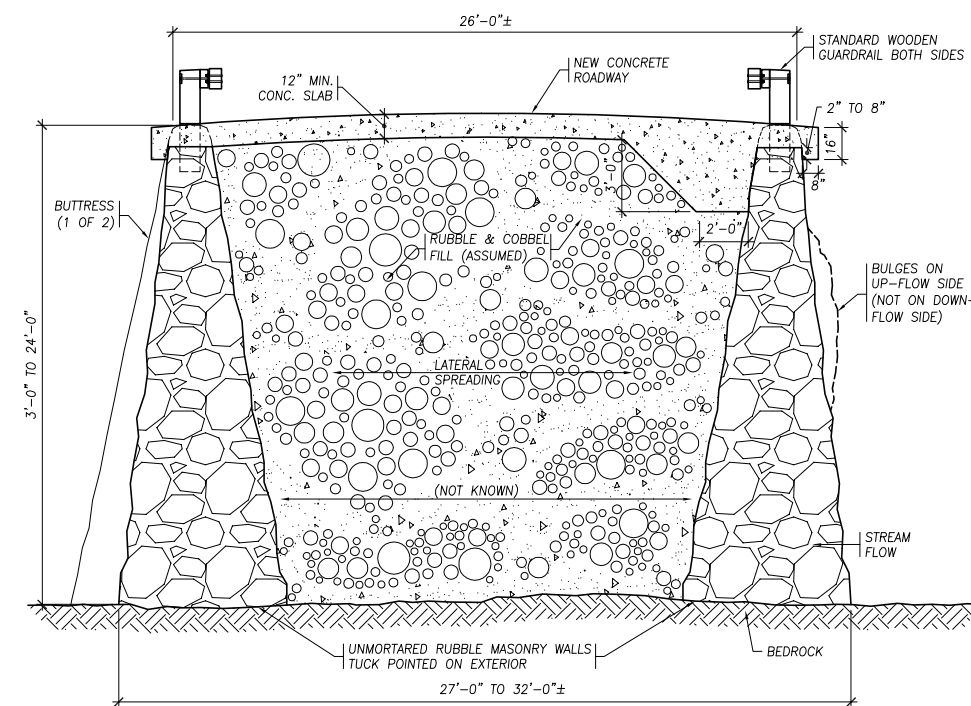
PROPOSED TRANSVERSE SECTION

FIG. B: HYBRID SCHEME TRANSVERSE SECTIONS
